STABIL-LOC[®]

FOUNDATION PIERING SYSTEMS

THE STABIL-LOC® FOUNDATION PIERING SYSTEM

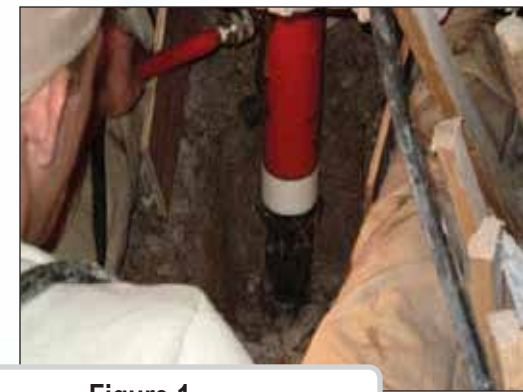
Figure 1
Pier is driven to bedrock under center of wall being lifted

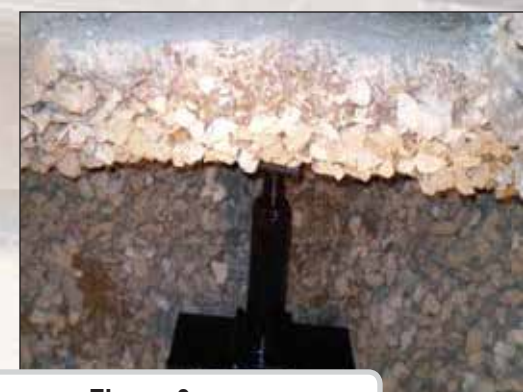
Figure 3
Structure is now carefully lifted, or stabilized to eliminate further settlement

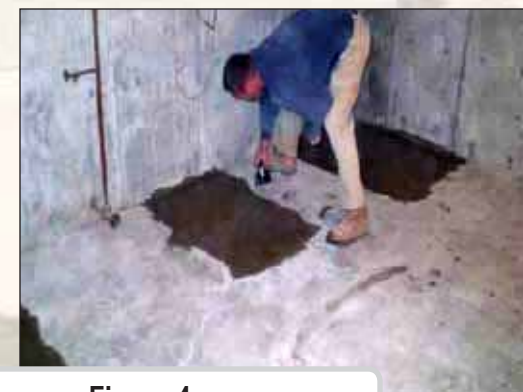
Figure 4
Immediate work area is filled in with new concrete
